Flood Control Project Maintenance
2014 Structure Summary Report
Overall Unit and Item Ratings

Lower San Joaquin Levee District

Ash Slough Drop Structure No. 1

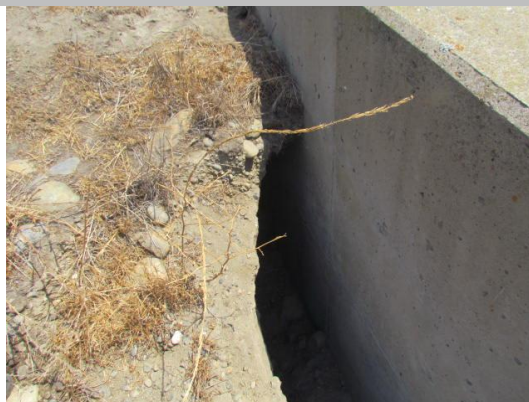
Photo 1 of 2 : ST_2014_NA0010_25_17_20140811_00012.jpg

LM Start	0.00	Rating **	M	Issue No.	17
LM End	0.00	Issue Type +	Ma	Location *	
Category	Structures & Concrete Lined Channels			GPS Latitude/Longitude	
				Start	End
Item	Concrete Foundations			37.037853 °	37.037853 °
				-120.440067 °	-120.440067 °
DWR ID	DWR_NA0010_25_t_2012_17				
Action/Comments					
Inspector Comments: Large hole on the right wing wall 2-3 feet wide and 4-5 feet deep and 12-14 feet long.

Looking east at large hole near right wing wall.

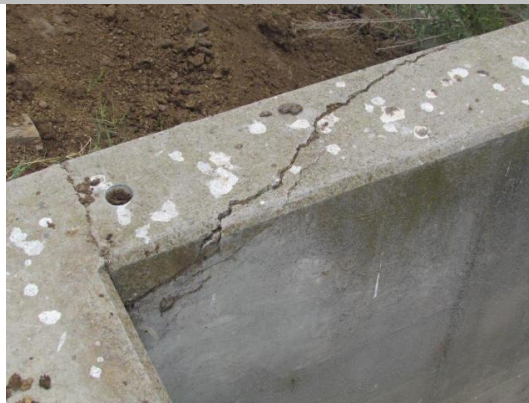
Photo 1 of 4 : ST_2014_NA0010_34_15_20140812_00016.jpg

Looking at cracking on left wing wall Summer 2014.

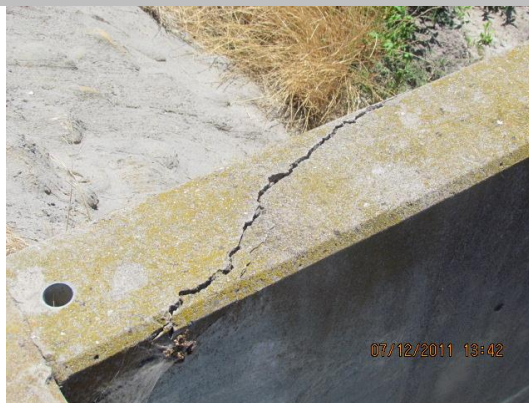
Photo 2 of 4 : ST_2014_NA0010_34_15_20140710_00008.jpg

Looking at cracking on left wing wall.

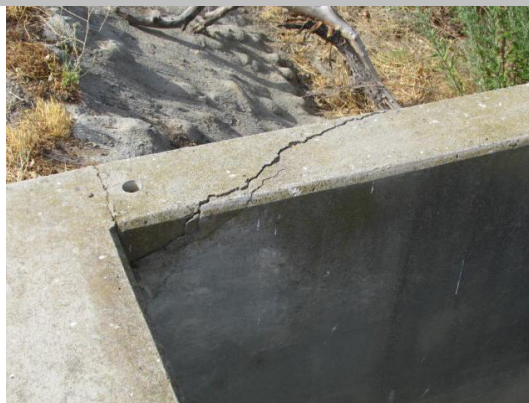
Photo 3 of 4 : ST_2014_NA0010_34_15_20140710_00009.jpg

Looking at cracking on left wing wall Summer 2013.

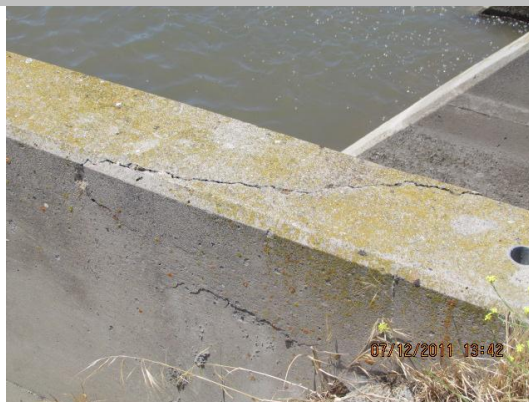
Photo 4 of 4 : ST_2014_NA0010_34_15_20140710_00011.jpg

Looking northwest at cracking on left wing wall.

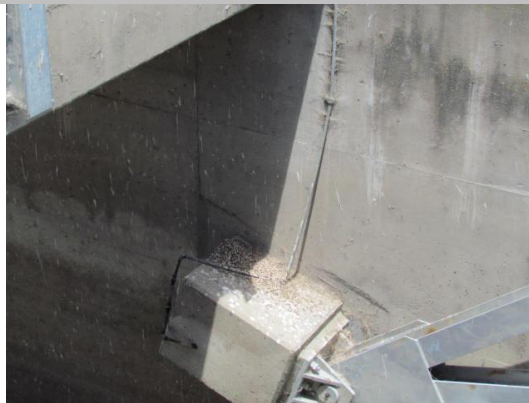
Photo 2 of 2 : ST_2014_NA0010_43_12_20140710_00003.jpg

Looking at grease tube disconnected from hing point.

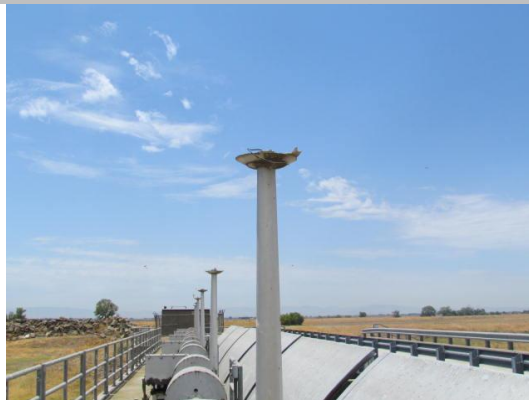
Photo 1 of 2 : ST_2014_NA0010_43_23_20140710_00007.jpg

Looking at missing light fixtures near electric gate operators.

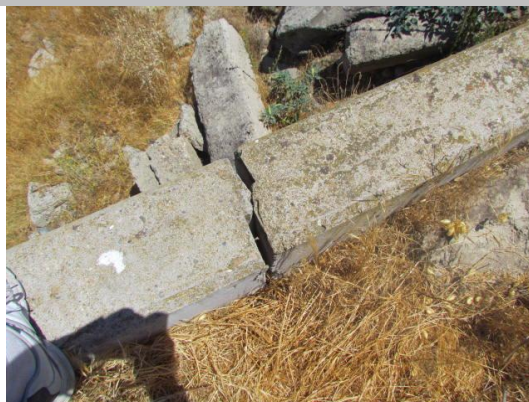
Photo 1 of 2 : ST_2014_NA0010_30_22_20140710_00004.jpg

Looking at joint separation on left side of structure (2013)

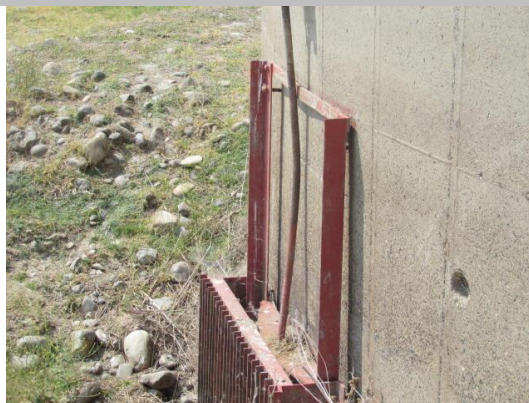
Photo 1 of 3 : ST_2014_NA0010_44_14_20140812_00015.jpg

Looking at south at bent stem on manual gate on downstream side of structure.

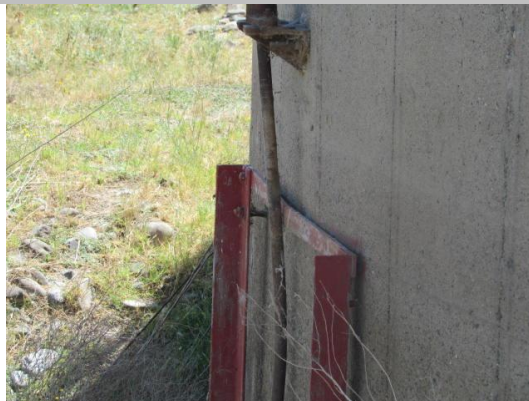
Photo 3 of 3 : ST_2014_NA0010_44_14_20140710_00009.jpg

Looking southeast at bent stem on manual gate on downstream side of structure.

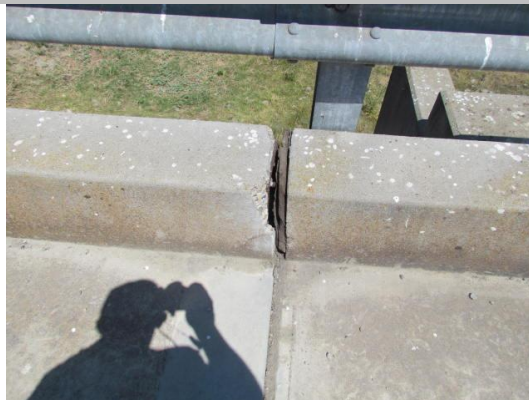
Photo 1 of 1 : ST_2014_NA0010_44_22_20140710_00010.jpg

Looking east at minor crack on joint at top of structure on the downstream side of structure.

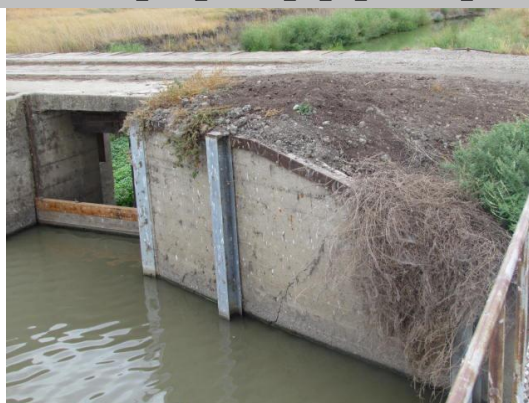
Photo 3 of 7 : ST_2014_NA0010_49_15_20140710_00004.jpg

Looking at right wing wall on upstream side of structure. Minor crack on wall.

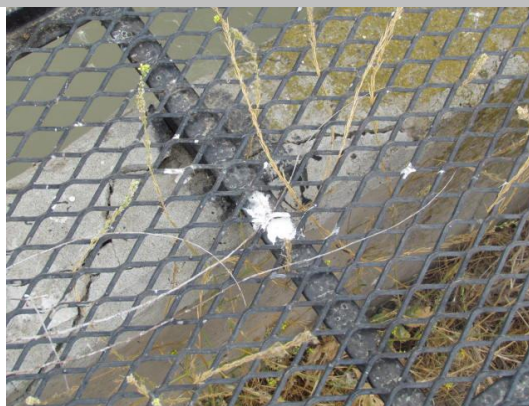
Photo 1 of 1 : ST_2014_NA0010_50_15_20140710_00005.jpg

Looking at cracking on headwall.

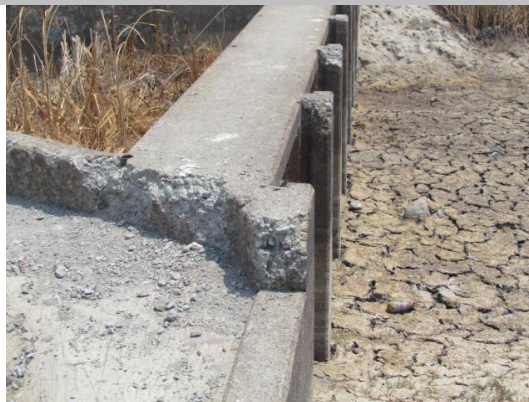
Photo 1 of 2 : ST_2014_NA0010_47_15_20140814_00018.jpg

Looking south at surface damage on San Joaquin structure.

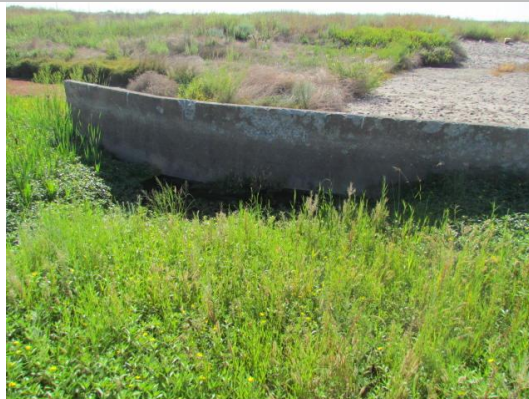
Photo 2 of 2 : ST_2014_NA0010_47_15_20140710_00009.jpg

Looking south at chips on left wing wall on downstream side of structure.

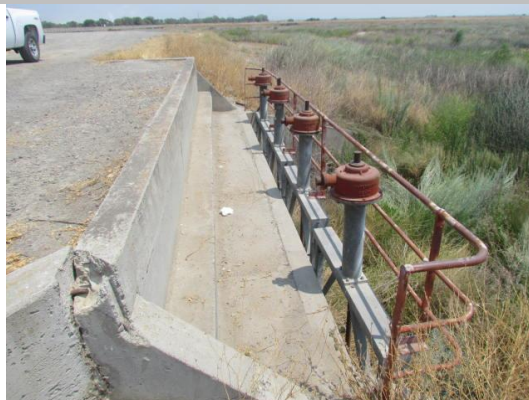
Photo 1 of 2 : ST_2014_NA0010_47_22_20140814_00019.jpg

Looking west at damage on left corner of Sand Slough structure.

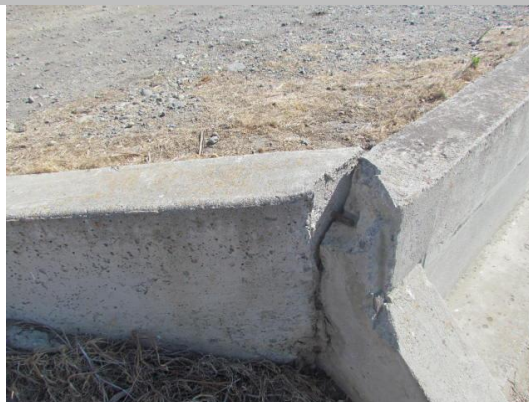
Photo 2 of 2 : ST_2014_NA0010_47_22_20140710_00010.jpg

Looking northwest at cracking on left corner joint.
